## INSPECTION CONDITIONS

1.8 INSPECTION SITE:

206 E Stephenson Street

# Inspection of 206 E Stephenson Street by ProSpector Home Inspections

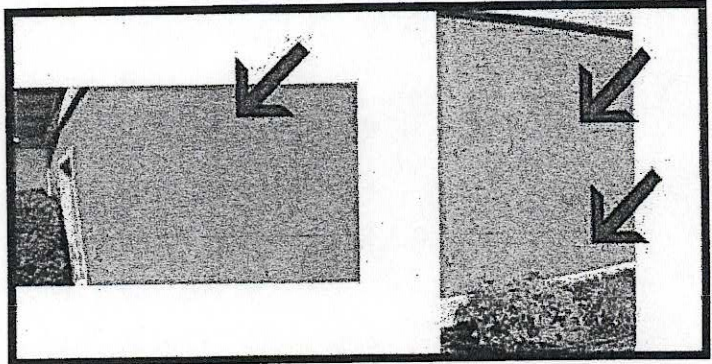
2.2

The front of the Building is an EIFS Finish there is some softness or looseness of the finish. This often shows some damage to the substrata. A mold test was done to find out if there is evidence of mold inside of the wall which would indicate the presence of moisture.

The damage on the front EIFS should be investigated further using destructive testing as the mold test is only an investigative tool not a complete and definitive answer  
Mold was found inside of the wall see attached mold test

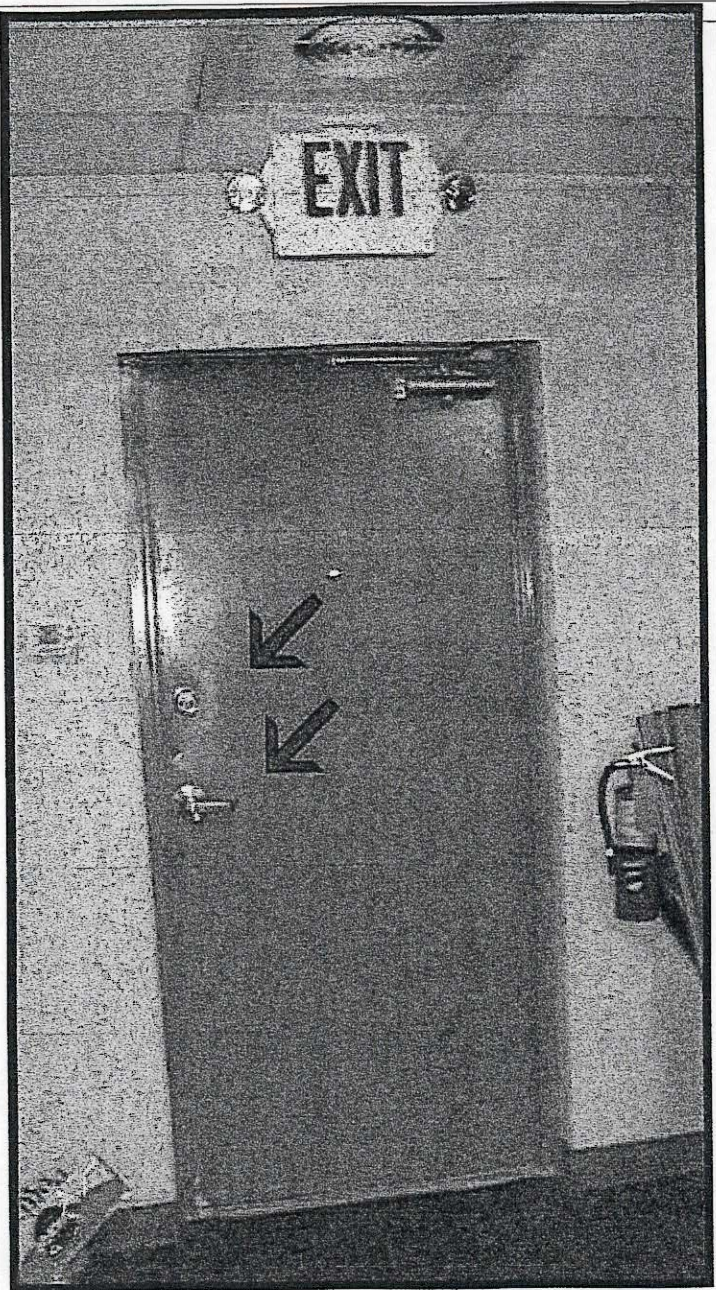
2.13 *Rear Entry Doors:*

Good condition. however it should be noted that the rear door has a deadbolt and no panic hardware this is a code and safety issue and should be addressed consult with the fire department and the Building official as to the prevailing standard for Freeport

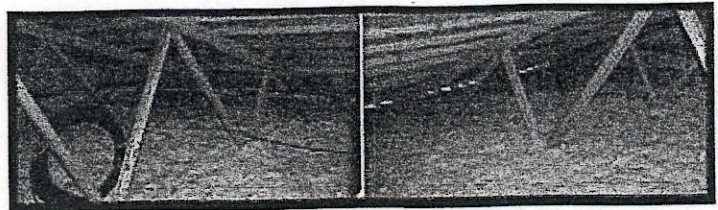
### 3.12 Predominant Type and Estimated R-Value:

12 inches blown Fiberglass: R-30

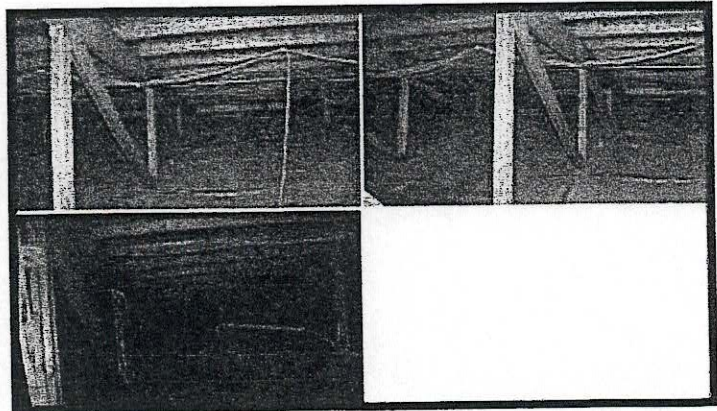
3.14

Ridge vents Ceiling insulation is contacting the underside of the roof sheathing in the area over the exterior walls. Air flow is being restricted to a large part. Insulation can be removed back in an attempt to restore air flow within the attic area.

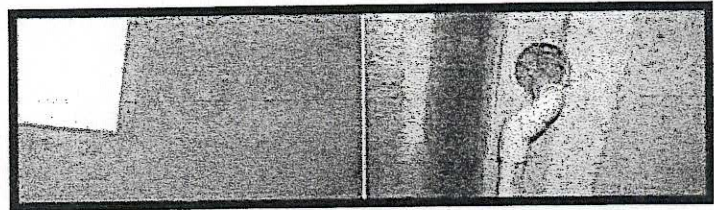
Good overall condition. Some ceiling tiles are damaged and in need of replacement or cosmetics these were not from leaks but rather from condensation

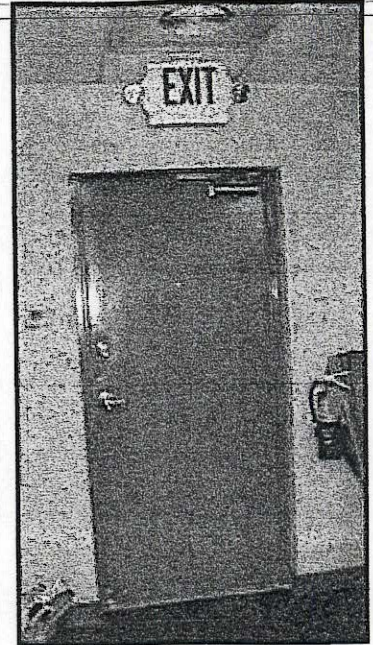
Good. however rear door should have panic hardware installed and the deadbolt removed
